CRANBROOK REGION

PHOENIX

Property name: PHOENIX
Map number (see Appendix C): 20
Mine drainage sample numbers: LB00-1801 to 1803
MINFILE number: 082ESE020

Date: September 11, 2000
Persons present: Steve Wuschke (Mining Division, Cranbrook) and L. Barazzuol (Mining Division, Victoria).
Weather: sunny and warm, late afternoon

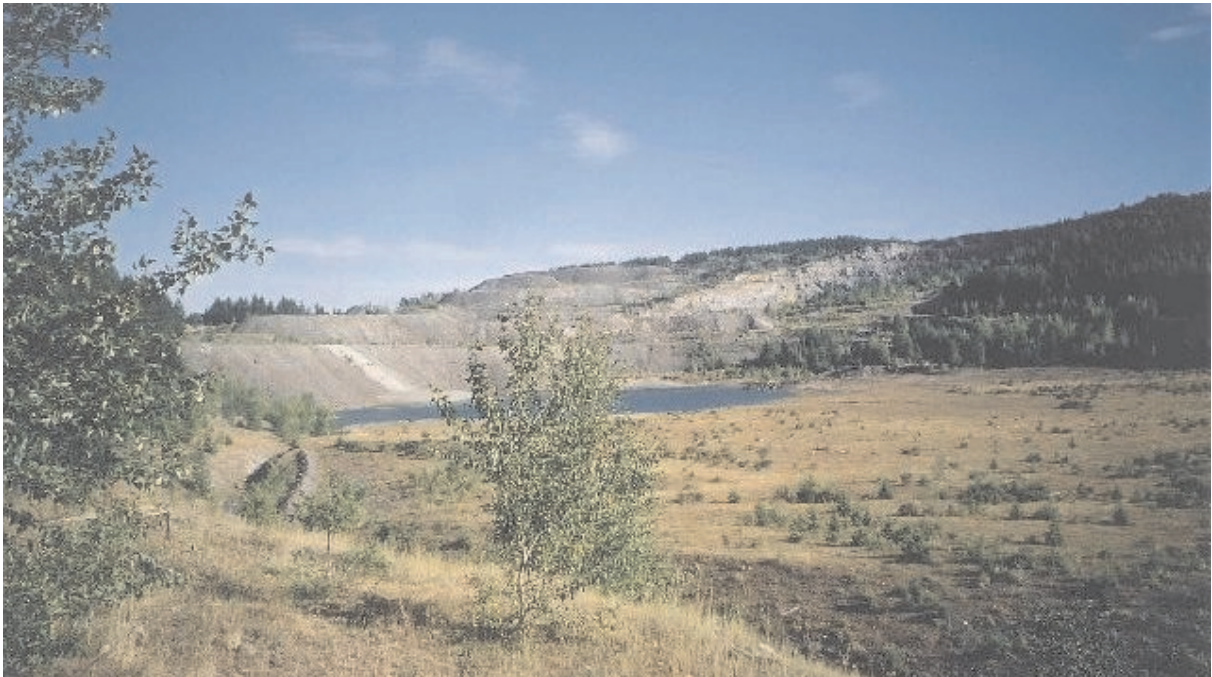
Photo 27. Phoenix tailings, tailings pond and dumps. The workings in the background include an open pit.

The tailings pond was well vegetated with signs of habitat formation. The field pH = 5.5. No conductivity measurement was taken. The riparian zone was naturally revegetating with young plant species although there was some minor iron staining. Plants included bulrush, cat tails and horse tail. There was also a dark green moss growing in the water. Amphibians were present in the pond. The water was organic smelling. Water was sampled on the east side of the tailings.

Results from the tailings pond water analysis include: pH = 8.0, [SO₄]=637 ppm, hardness = 196 ppm. The concentrations of heavy metals, both dissolved and total are below the BC water quality guidelines for aquatic life.

- only parameter of concern is the SO₄ concentration, which exceeds the numeric guideline

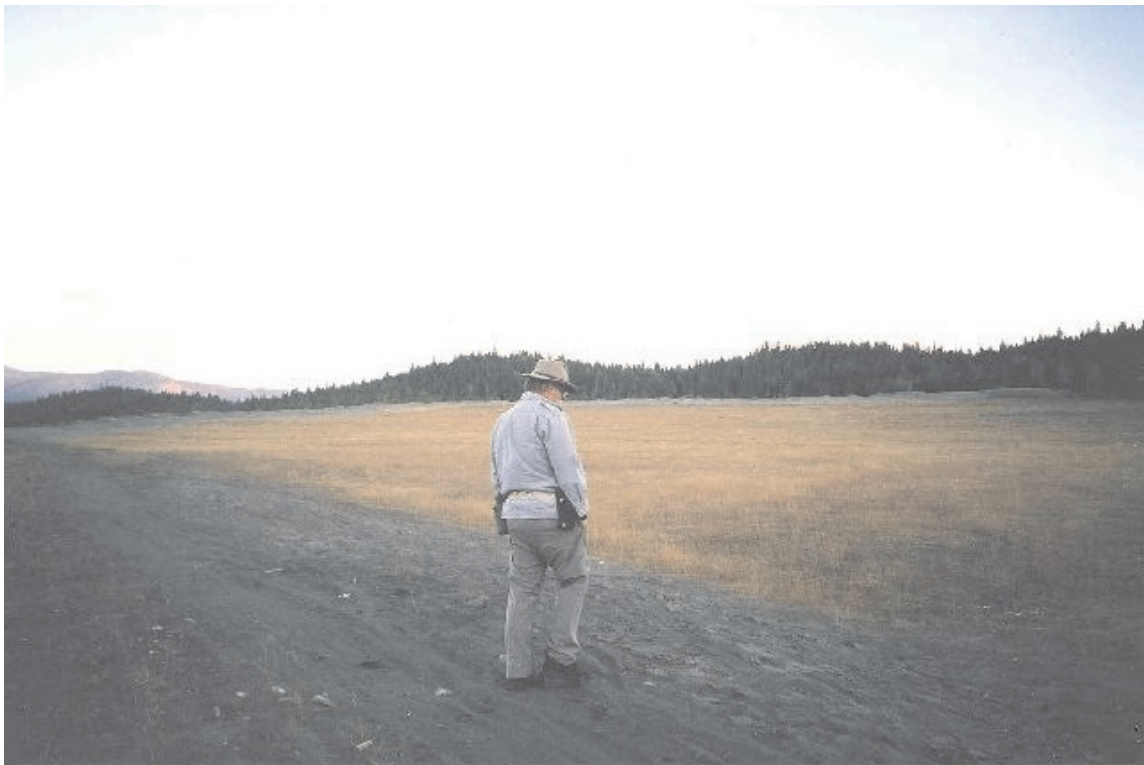
The tailings are well vegetated, a result of hydroseeding. The grain size of the tailings is coarse, especially at the dam walls where they had been cycloned. The tailings are unoxidized.

Photo 28. Tremblay tailings facility.

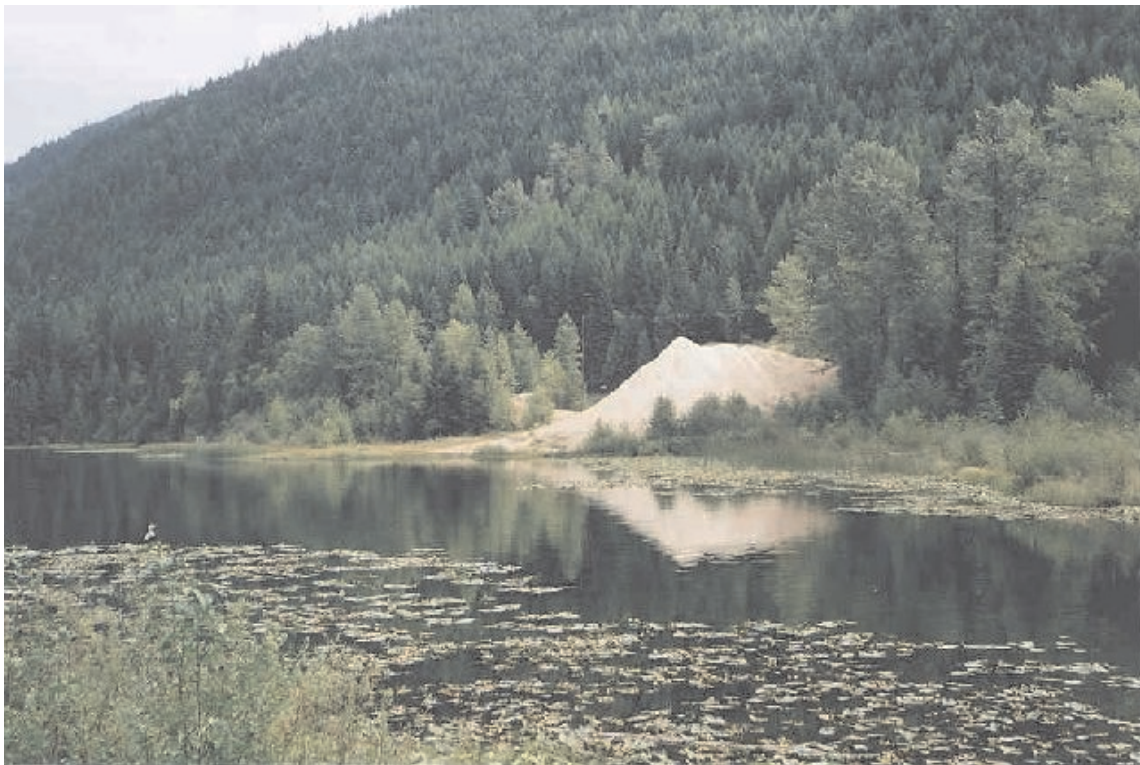
Photo 30. Jewel Lake tailings.

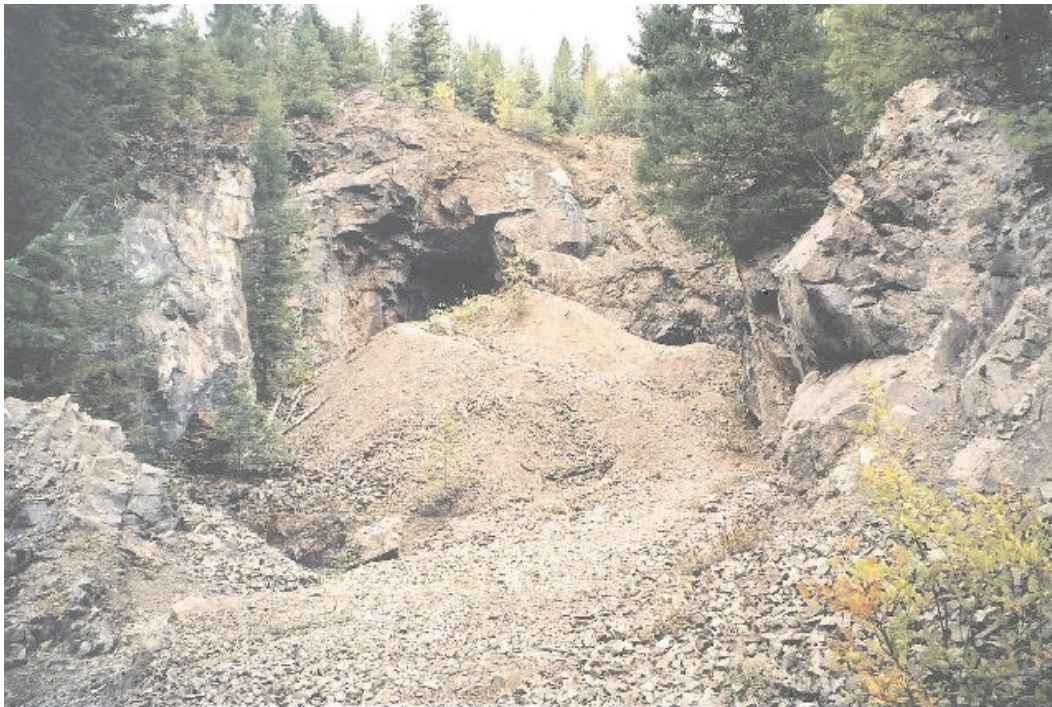
The area inspected poses to be a safety hazard, not so much an environmental. MINFILE states the workings cover 4 hectares. Only the workings adjacent to the road were inspected.

Photo 31. Oro Denoro adit.

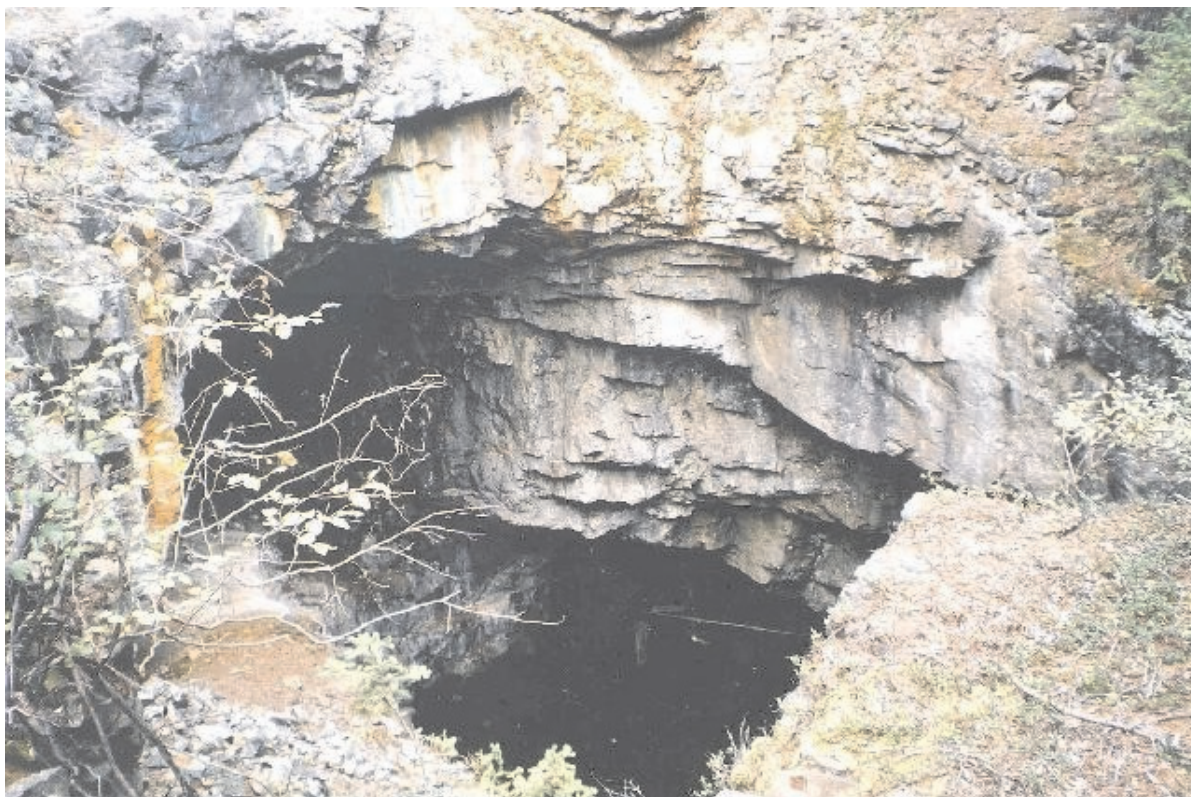
This site is a public safety hazard with the number and depth of the openings. Some rope and fencing is present, but in general, the openings are not well marked.

Photo 32. Stope at Emma.

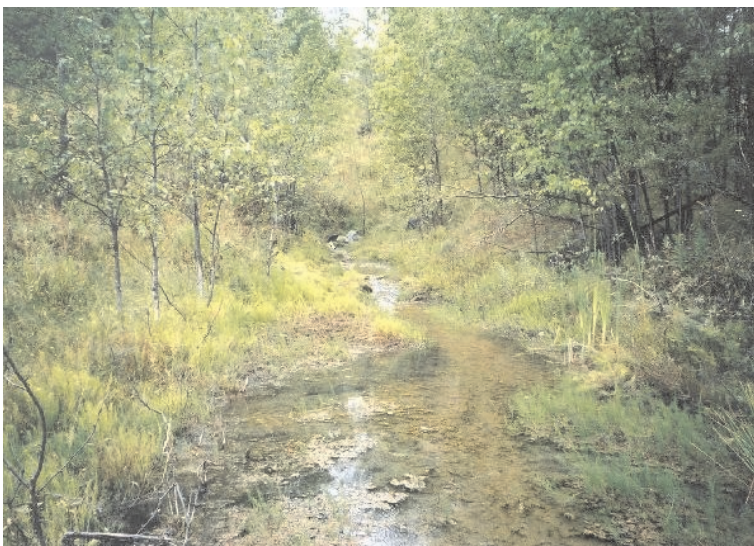
Photo 33. Drainage from Spitzee adit.

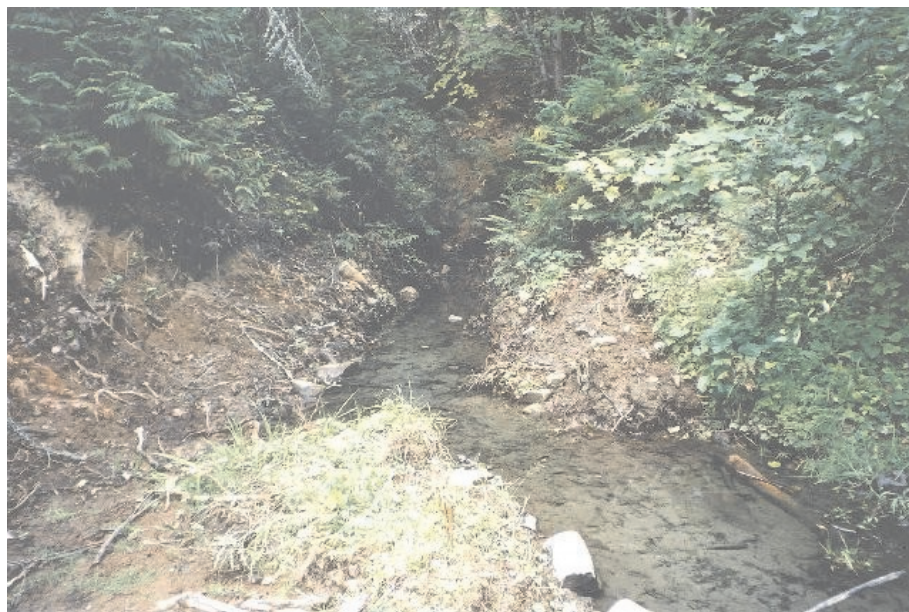
The field pH=5.5, conductivity 320 μ s and the flow ca. 80 L/min. The water had no odour. No vegetation present in the drainage channel. The backfilling and excavation was performed recently, thereby elevating the turbidity of the drainage. Minor Fe-staining of the rocks within the drainage was visible. The drainage was sampled.

Not a reclamation priority: drainage in compliance (although Zn is elevated) and the one portal has been backfilled.

Photo 34. Portal backfilled with a culvert in place at the Gopher mine site. The drainage was sampled.

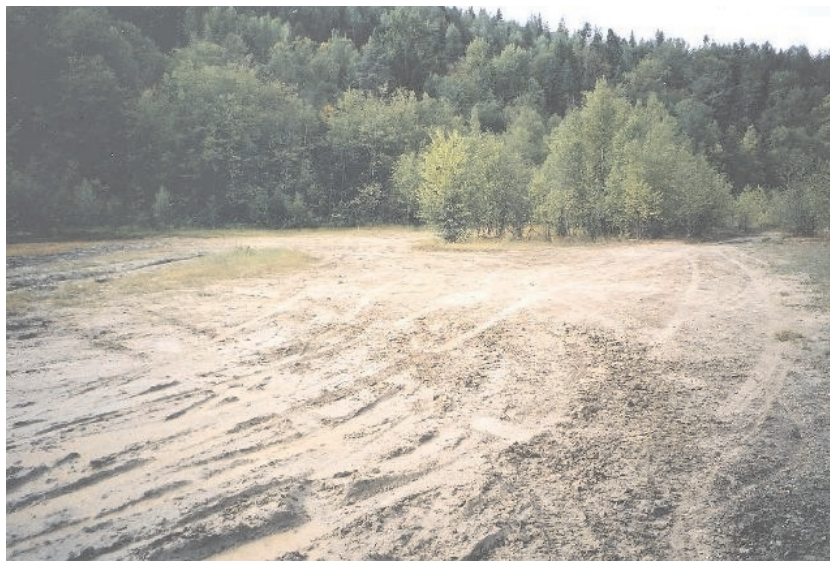
Photo 37. Kenville tailings.

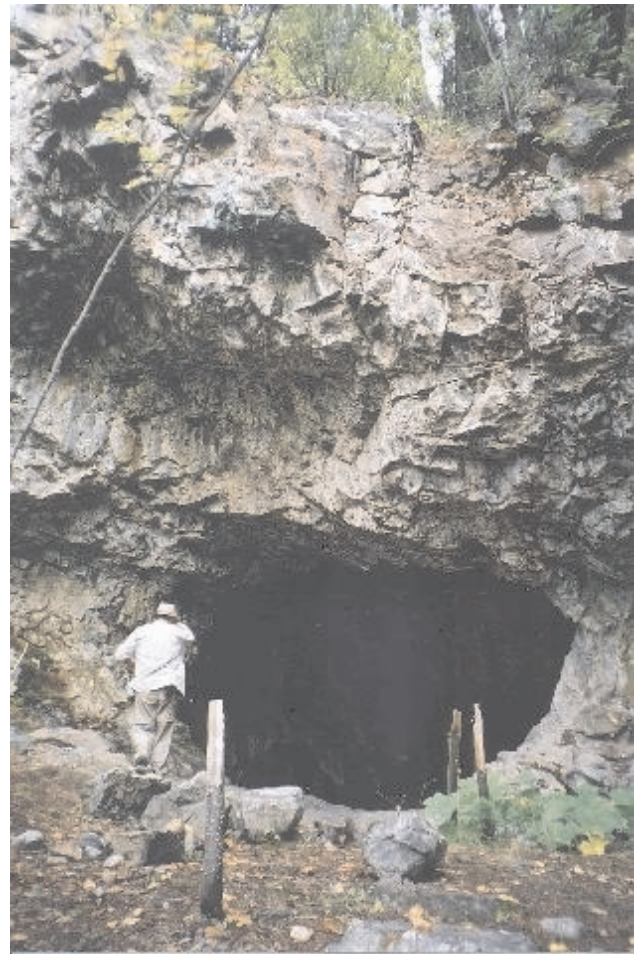
Photo 38. Queen Victoria stope.

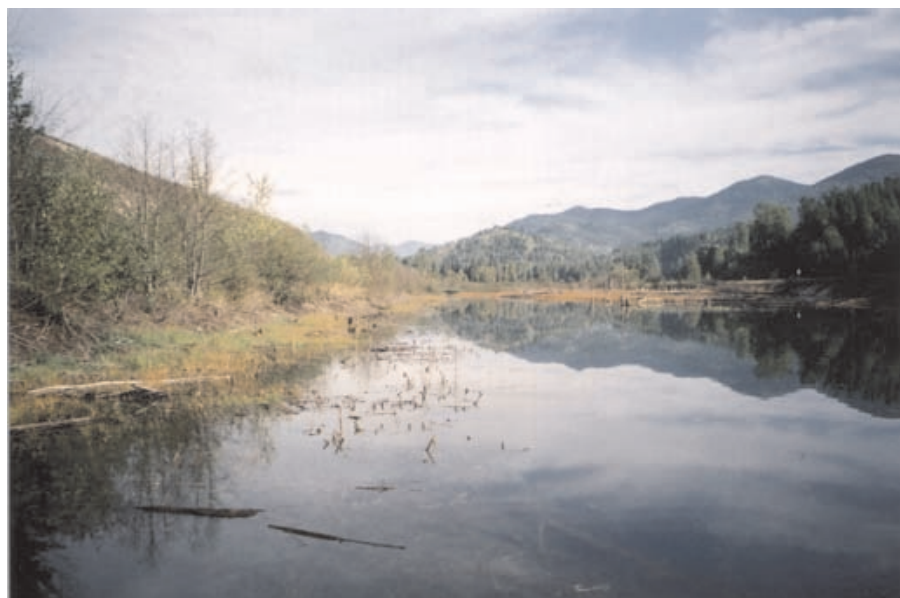
Photo 41. Pond at toe of the Canex tailings.

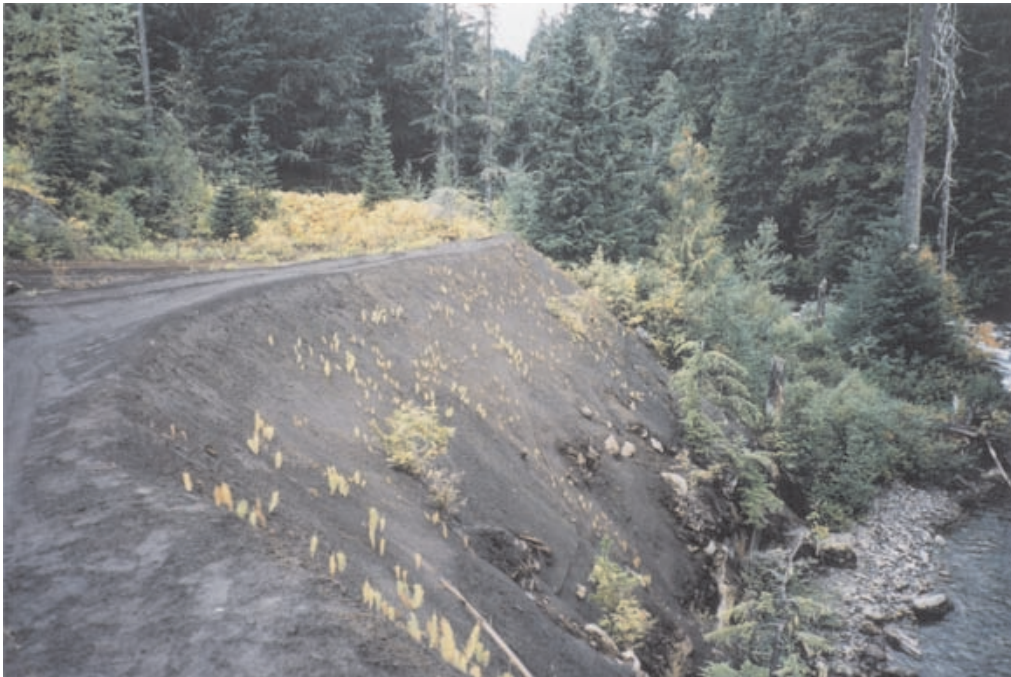
The silt-sized tailings are located down slope from the waste rock dump and the mill. Keen Creek runs along the northwest side of the tailings, likely washing some of the tailings downstream. The colour is chocolate brown, which is consistent with depth. The tailings forming a bank above the creek hosted various seeps as well as an embedded pipe. No drainage was flowing from the pipe. The inaccessible seeps created red stains and sustained some vegetation. Vegetation on the slope of the tailings includes conifers, thick, dark green-brown moss mats, horsetail and grasses. The top of the tailings is sparsely vegetated with sparse horsetail but most of the vegetation was on the creek-side slope. The tailings fizzed rapidly with HCl indicating carbonates. A spillway leading to the creek is located on the west side of the tailings impoundment. The area of the tailings is about 15,000 m² and the volume about 300,000 m³. The tailings were sampled.

Photo 43. Cork Province tailings.

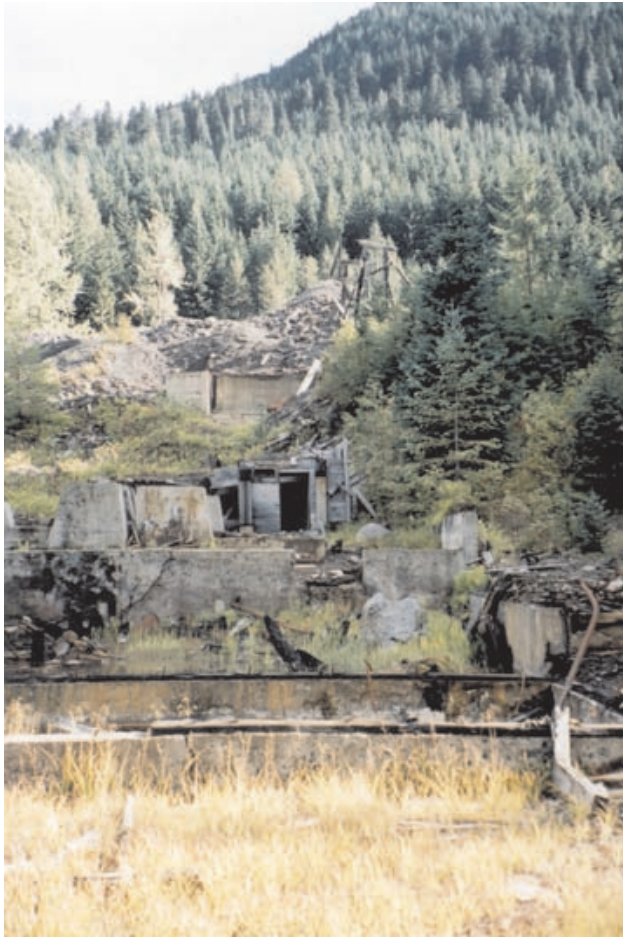
Remnants of the mill include the foundations as well as scrap metal and wood.

Photo 44. Cork-Province mill.

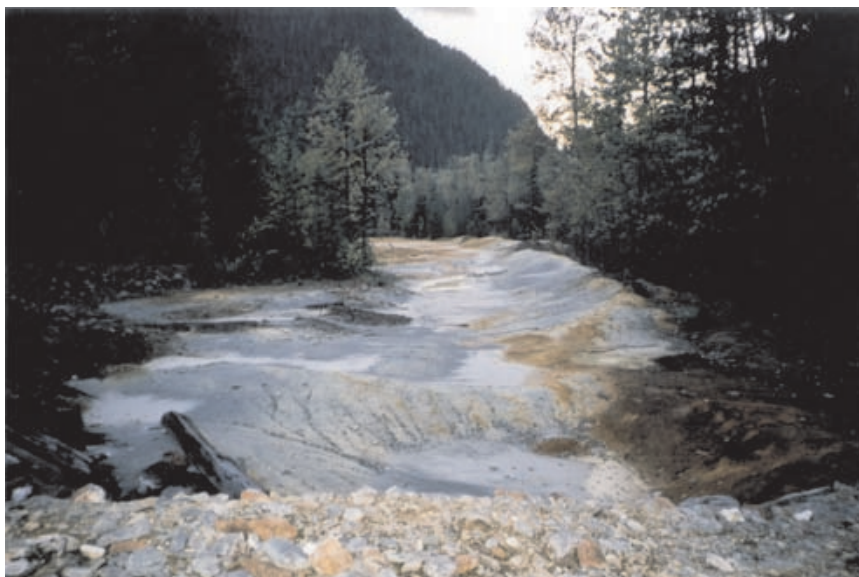
Photo 45. View of Camborne tailings from mill.

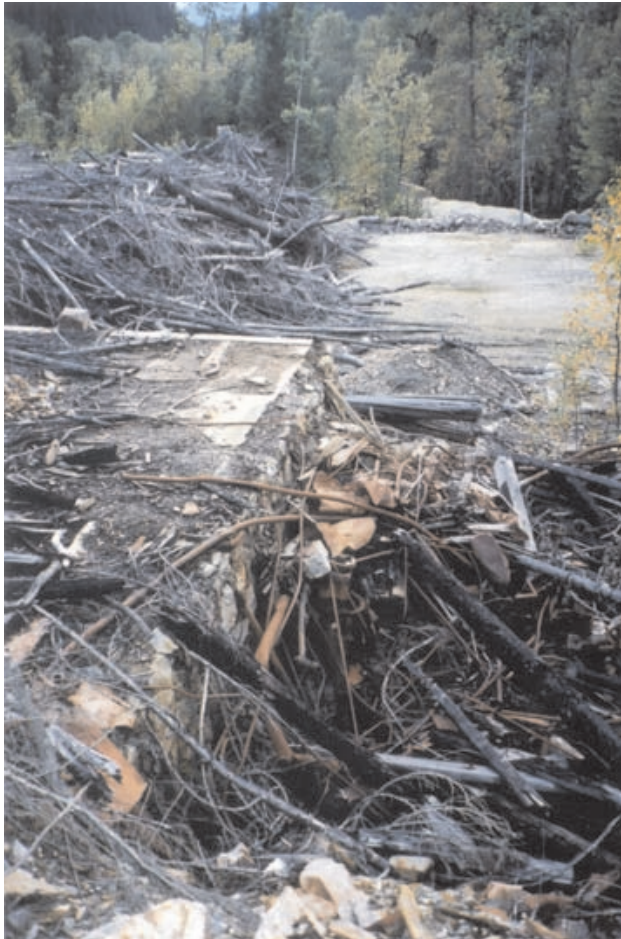
Photo 47. Camborne mill and tailings.

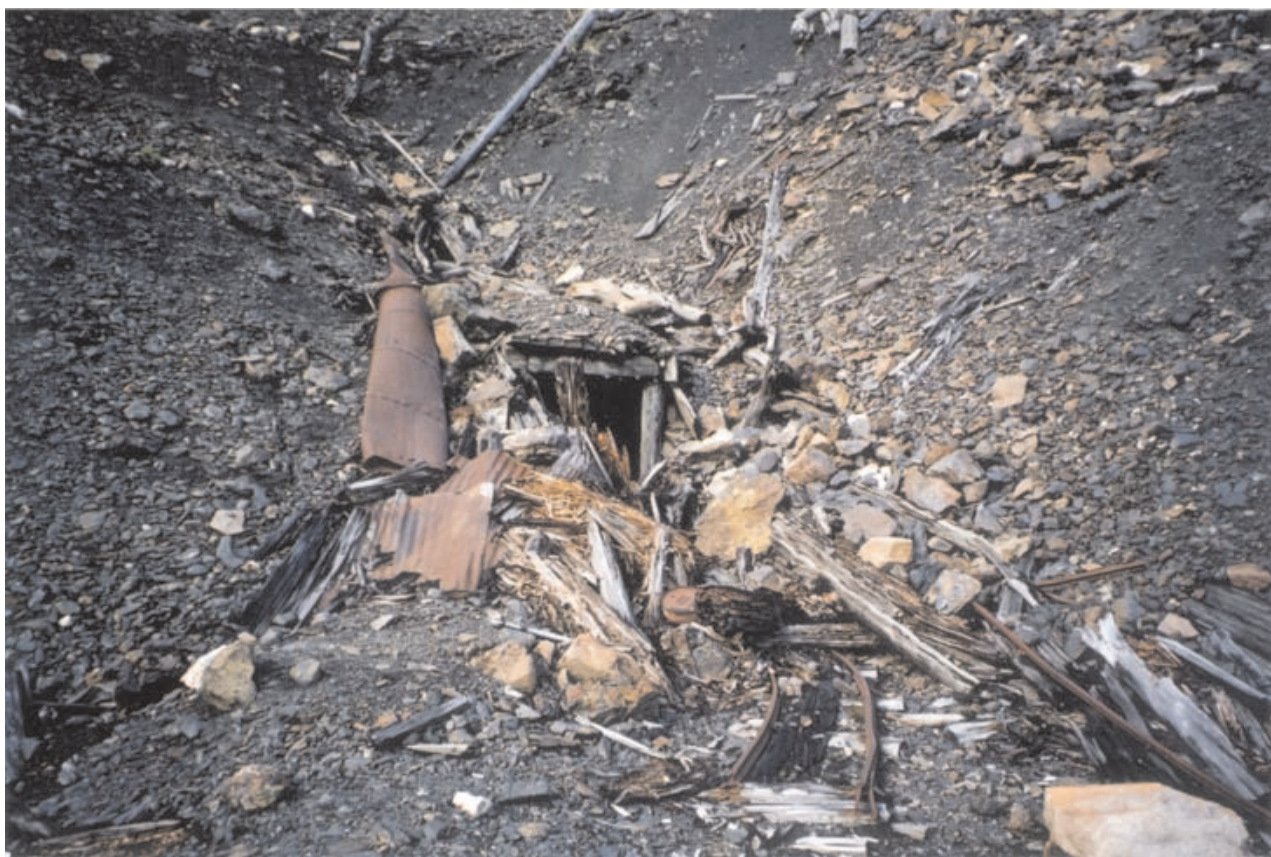
The lower adit is located beneath the 1796 m dump. The UTM coordinates were not taken but the elevation is approximate 1770 m. The portal is inaccessible due to slumped waste rock blocking the portal. Other debris such as rusting barrels, rail tracks and rotting wood is also present at the portal. Drainage was coming from the portal and was sampled.

Photo 48. Jackson adit (elevation 1760 m). The drainage flowing from the adit is not visible in the photo.

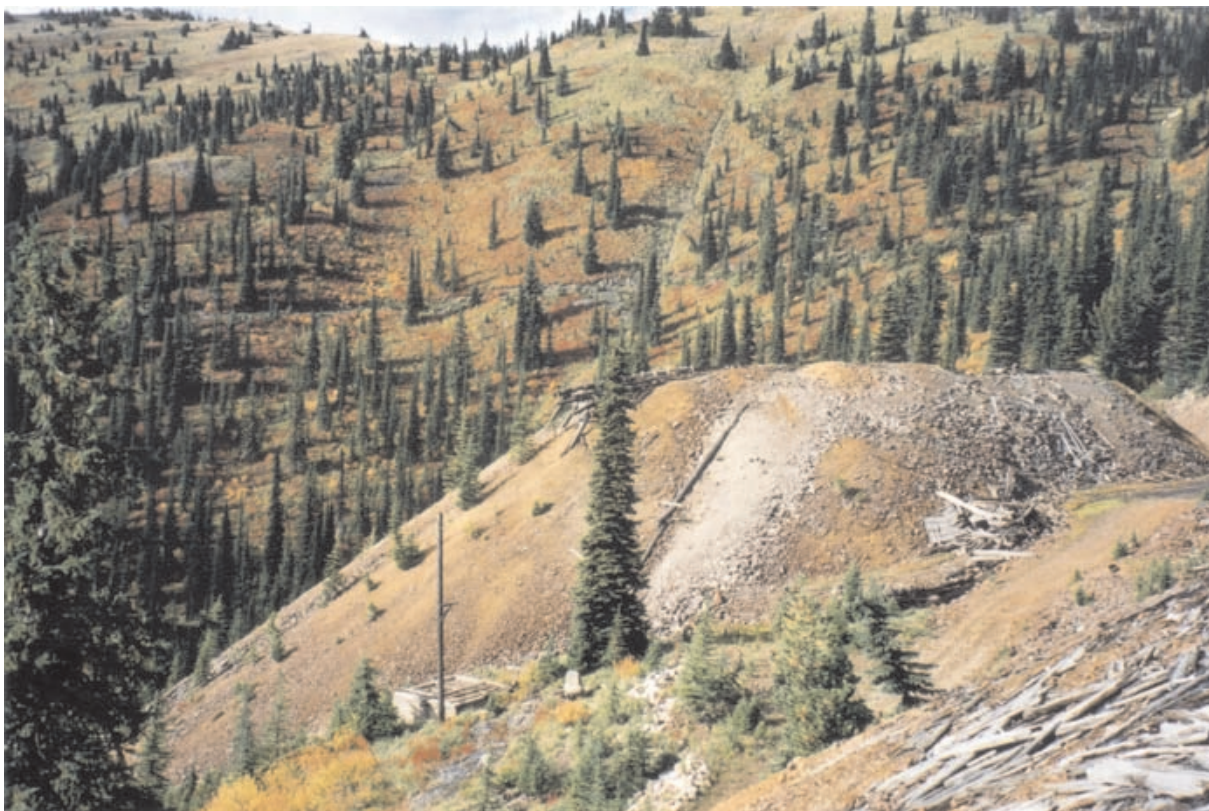
Photo 51. Waste rock dump, Reno mine site.

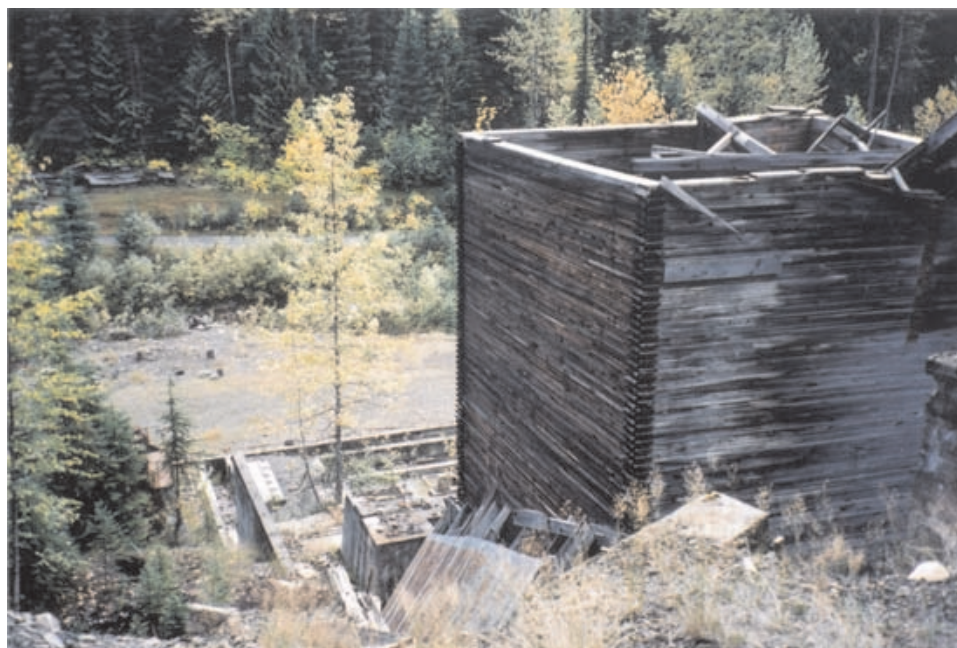
Various wooden mill buildings remain on site, including an ore bin, processing plant and a trestle. The ore bin and plant appear to be in good condition but the trestle is collapsing. Other unidentified, collapsed wooden structures are on site.

Photo 53. Unknown mill near Sandon, B.C. The mill could not be linked to specific mine sites.

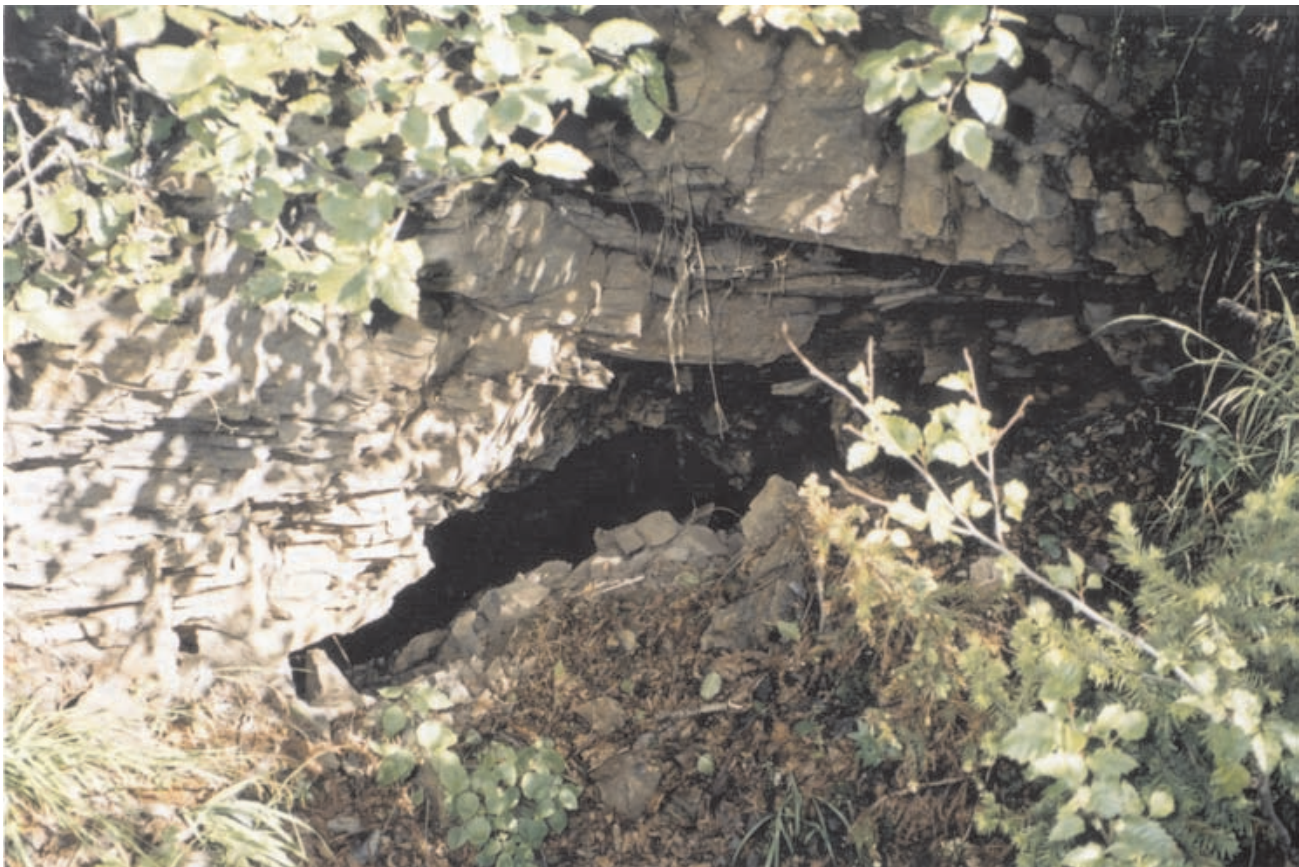
A partially collapsed portal with drainage was inspected. The pH of the drainage was 5.5 and conductivity 170 μ s. The flow was ~ 5 L/min and the drainage odourless. No oxidation was visible around the portal. A small waste rock dump was situated to the west of the portal. The UTM coordinates: 481630, 5536572; elevation 1316m. The workings could be part of the New Springfield (082FNW199) mine site.

Photo 54. Unknown adit on Idaho Peak, elevation 1419 m.
